Point Reyes National Seashore
Coastal Watershed Restoration Project

Coastal Watershed Restoration Program –
Geomorphic Restoration Project - Environmental Assessment
Figure 2.4

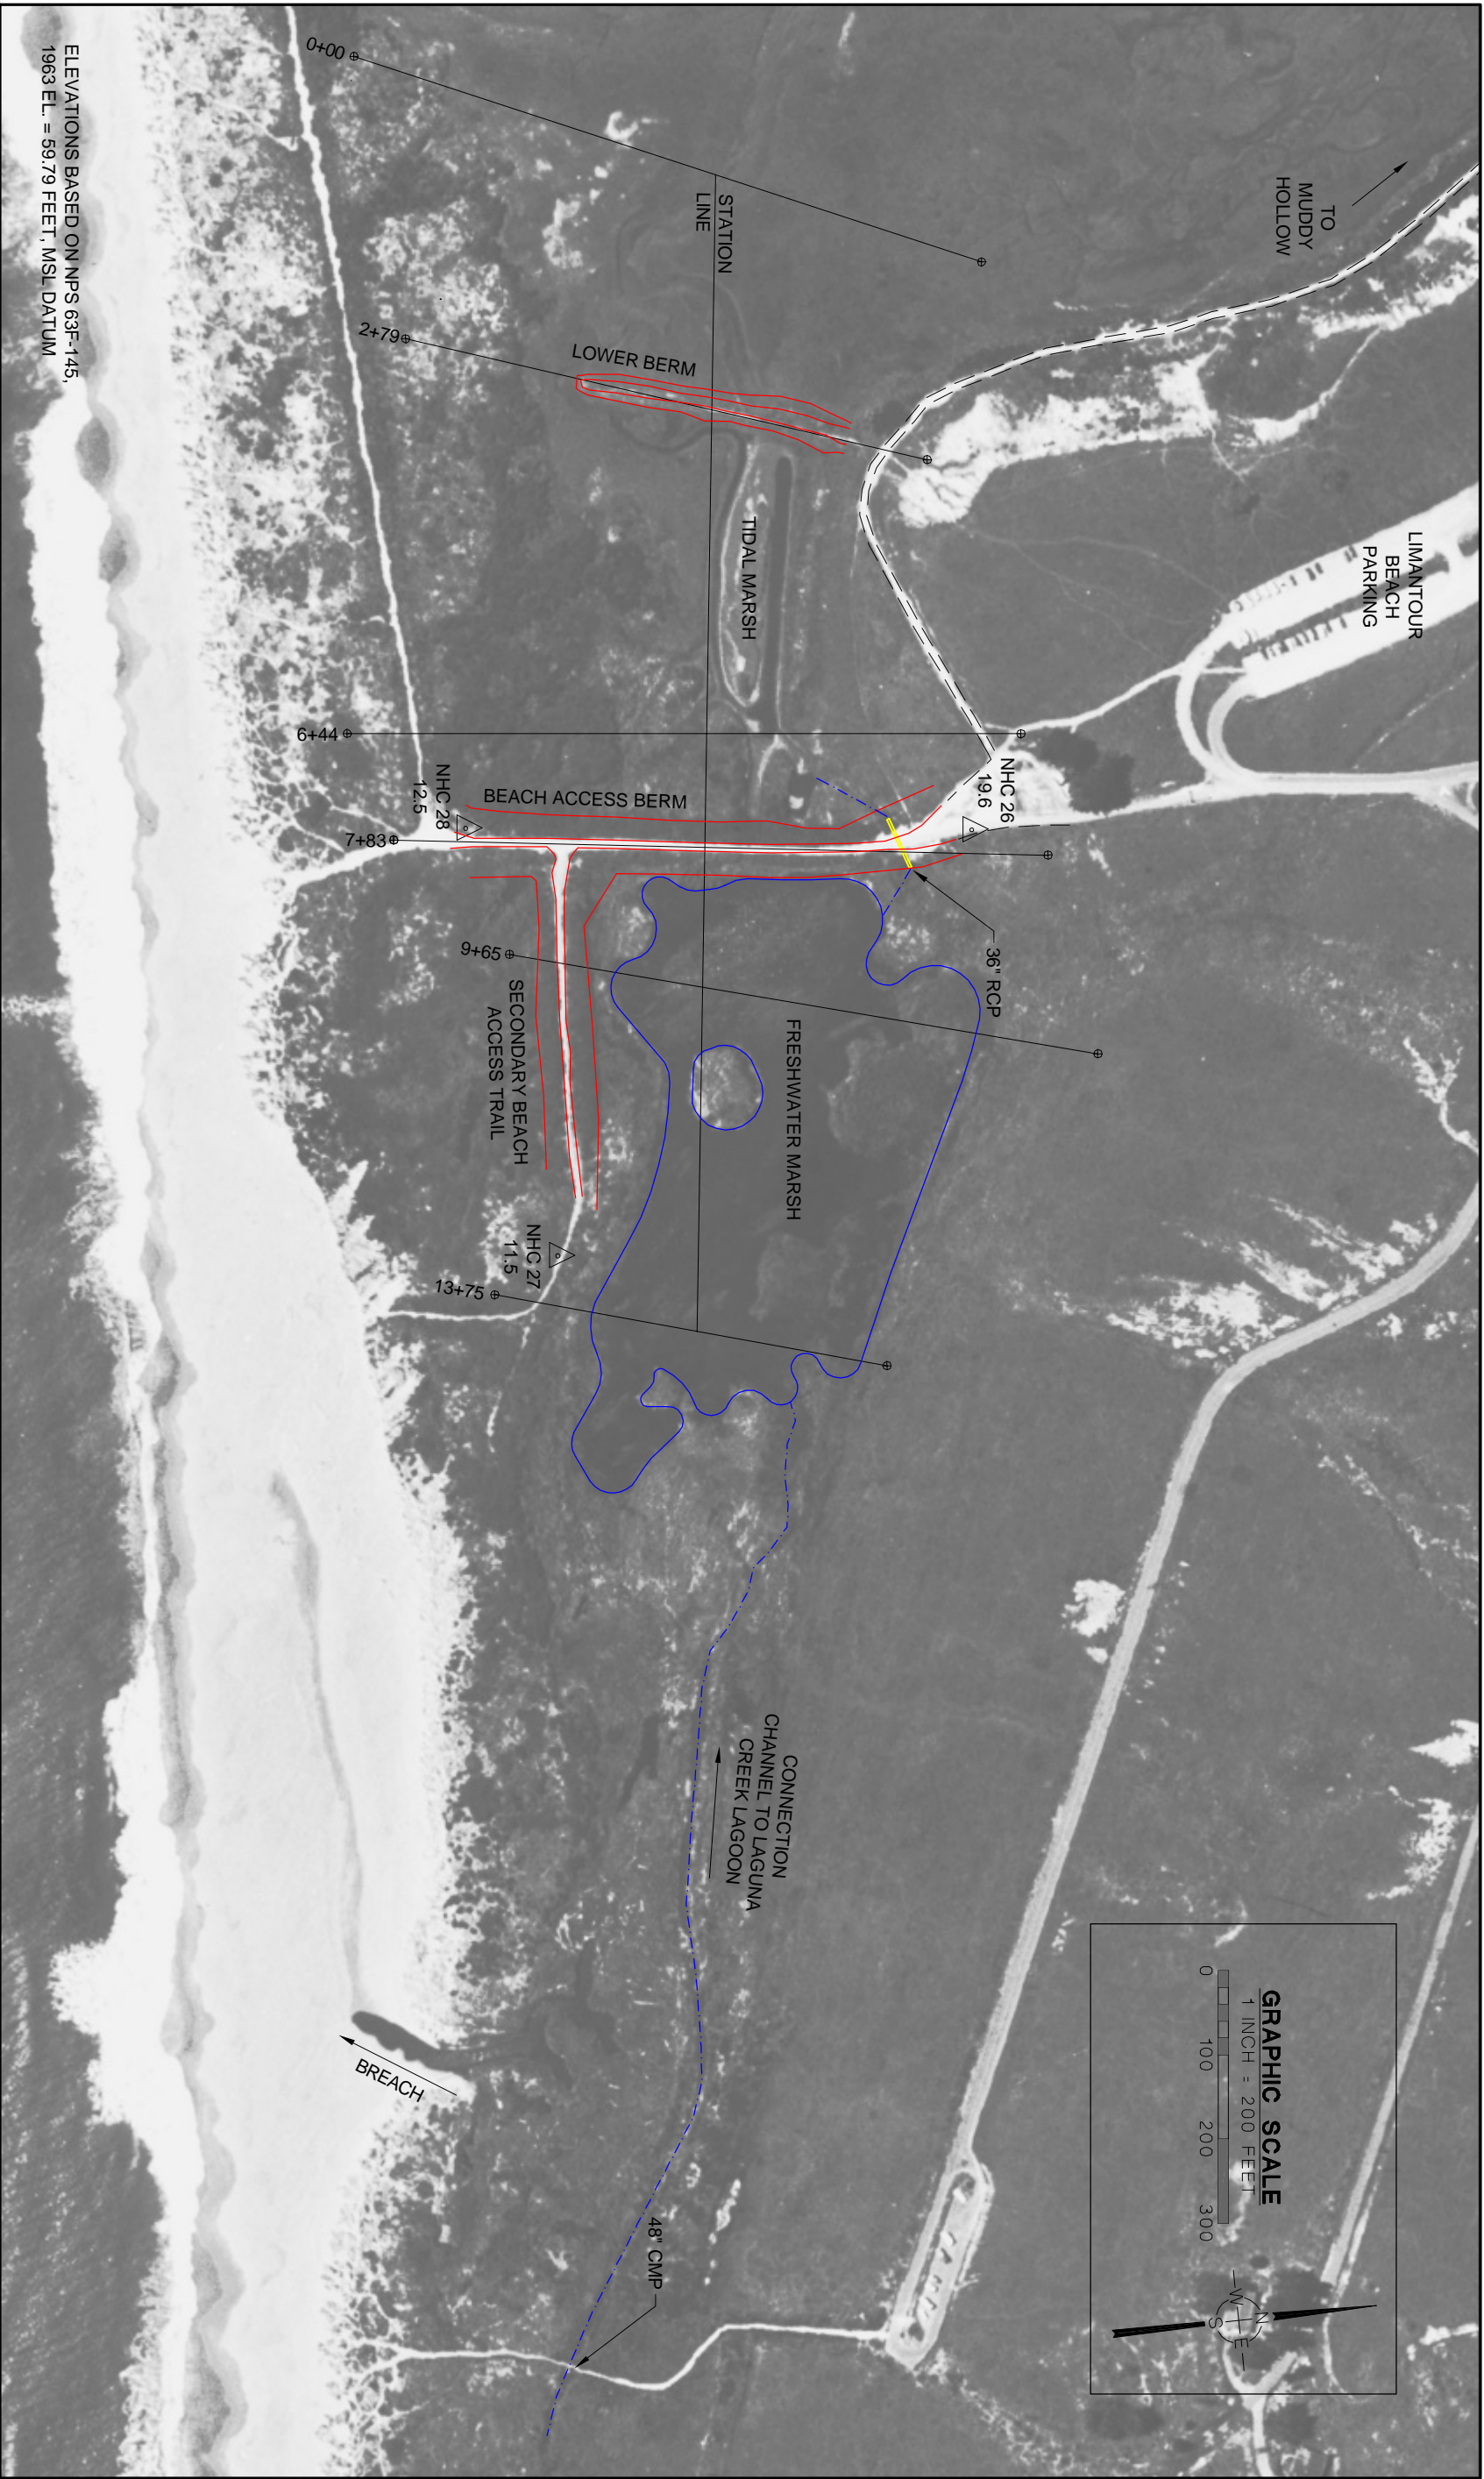
Figure 21. Limantour Beach Marsh Existing Conditions Site Plan

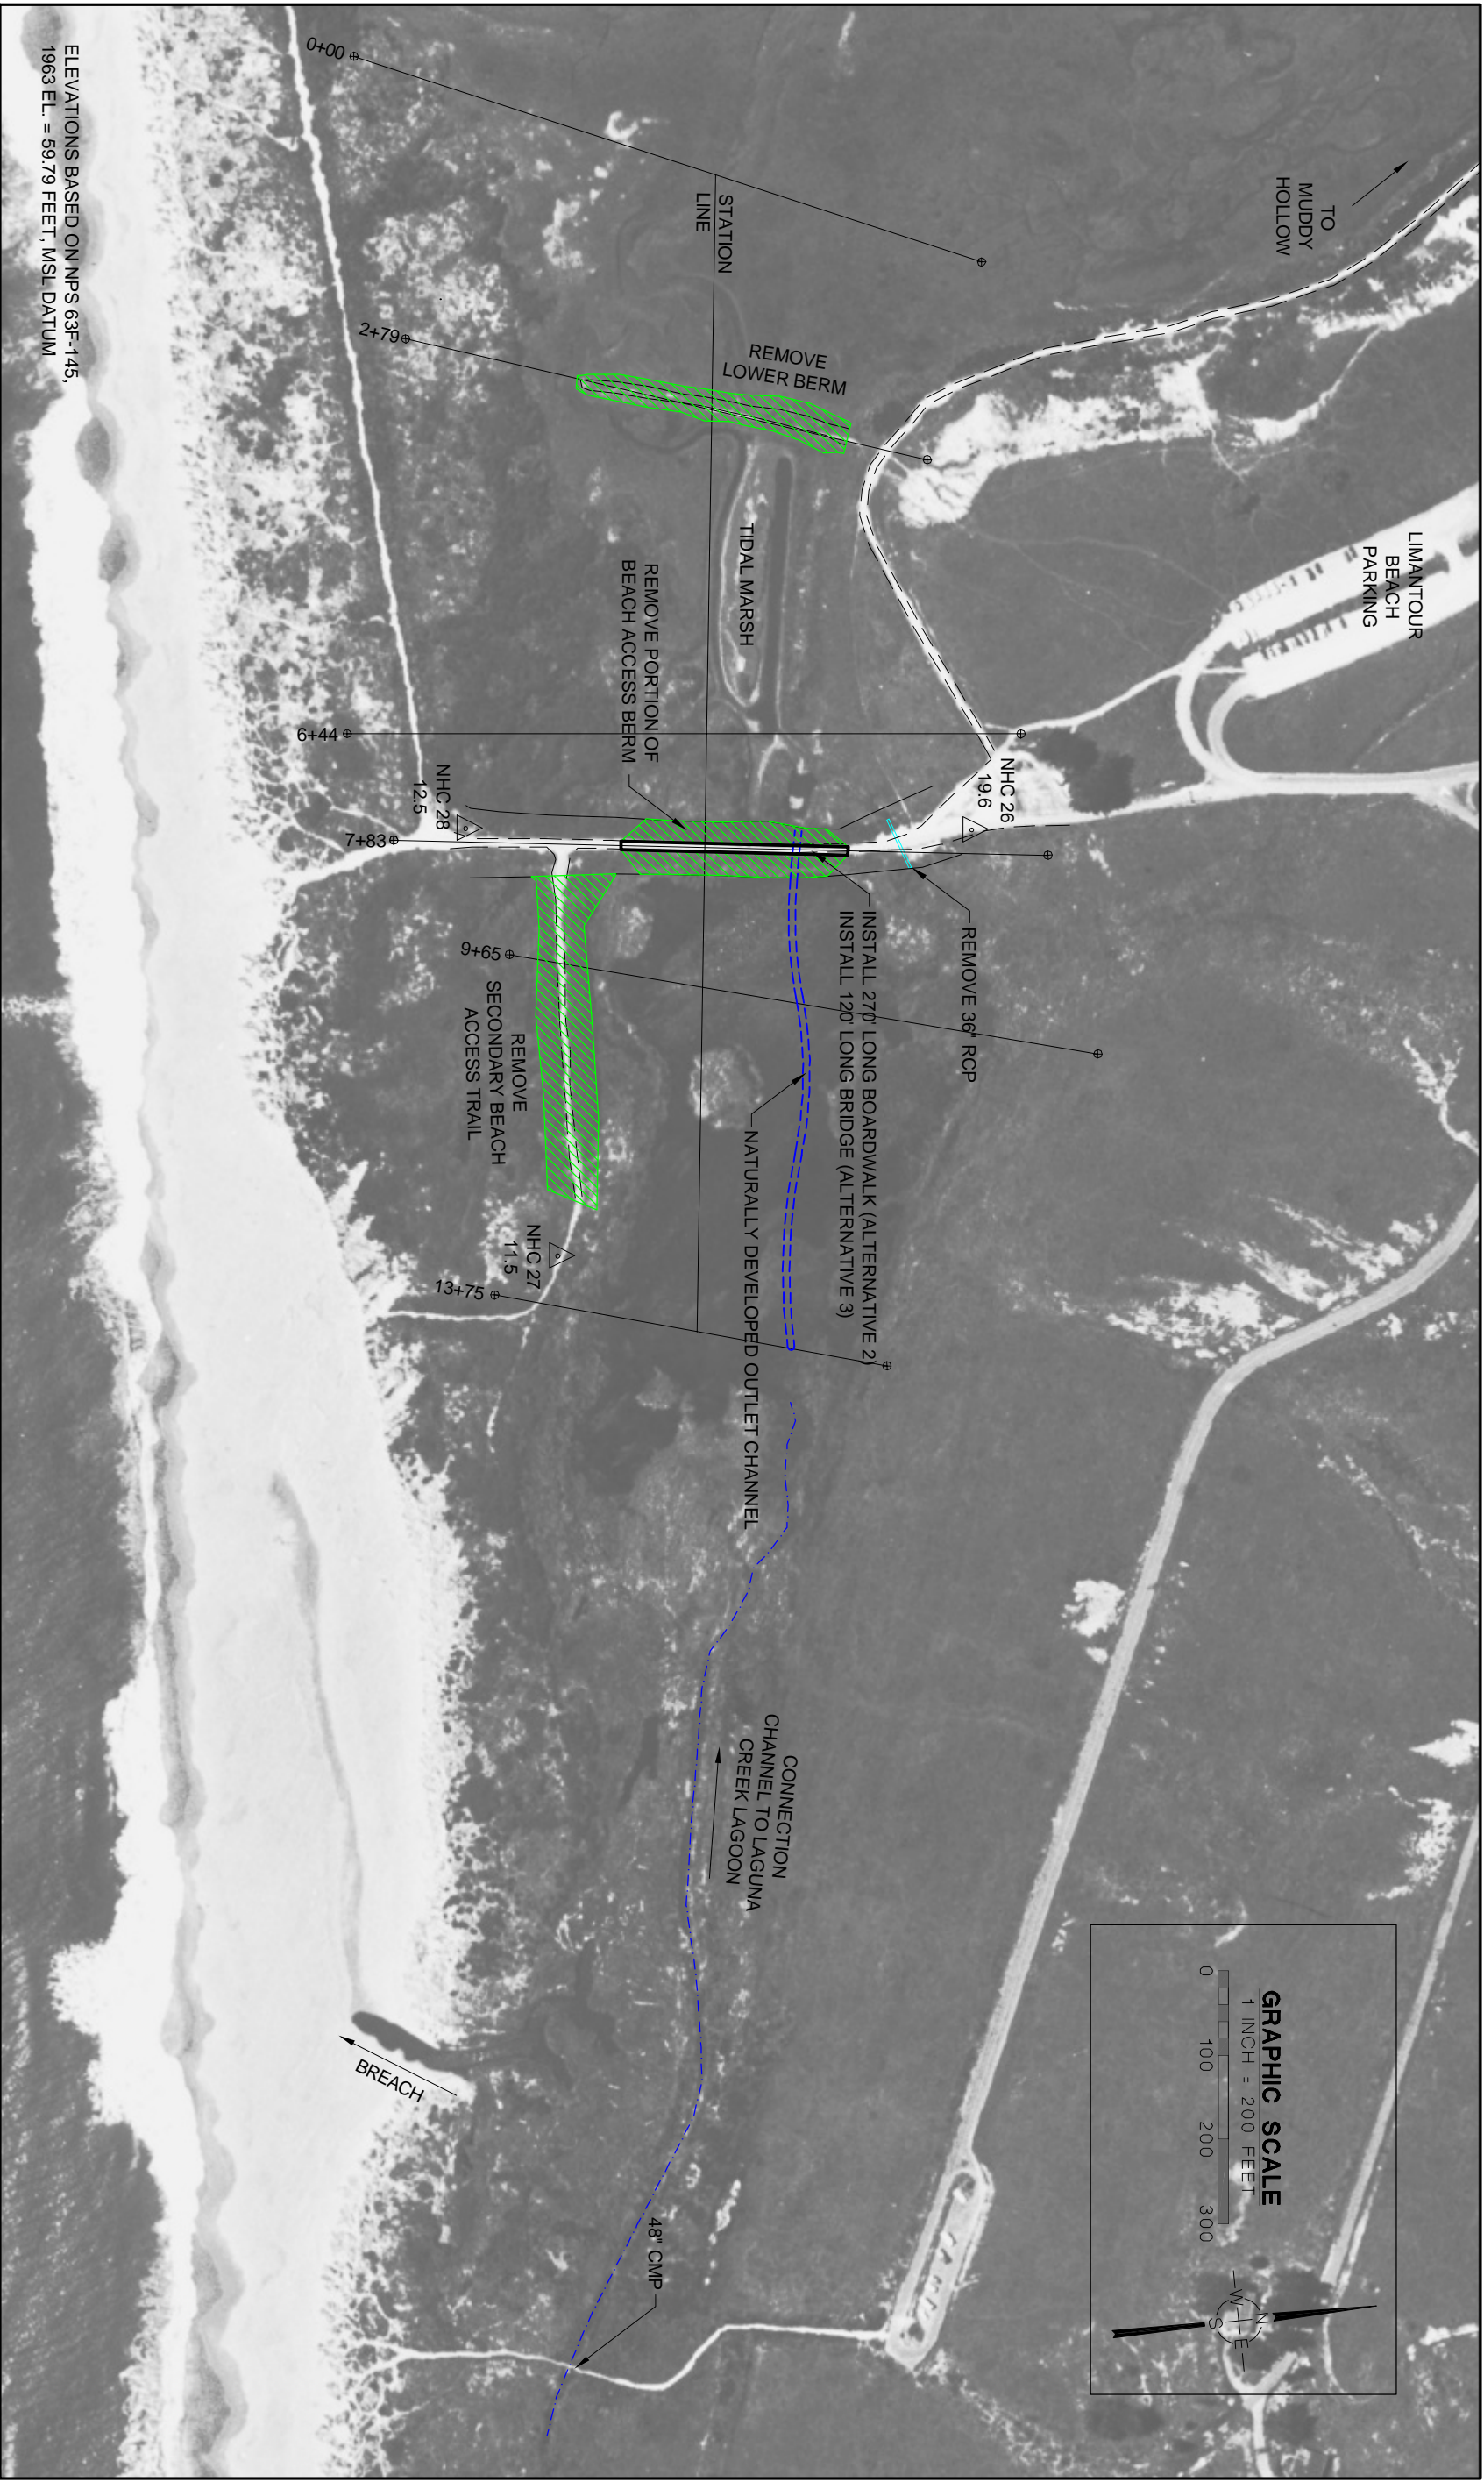
Figure 24. Alternative 2 and Alternative 3: Limantour Beach Marsh Restoration Plan

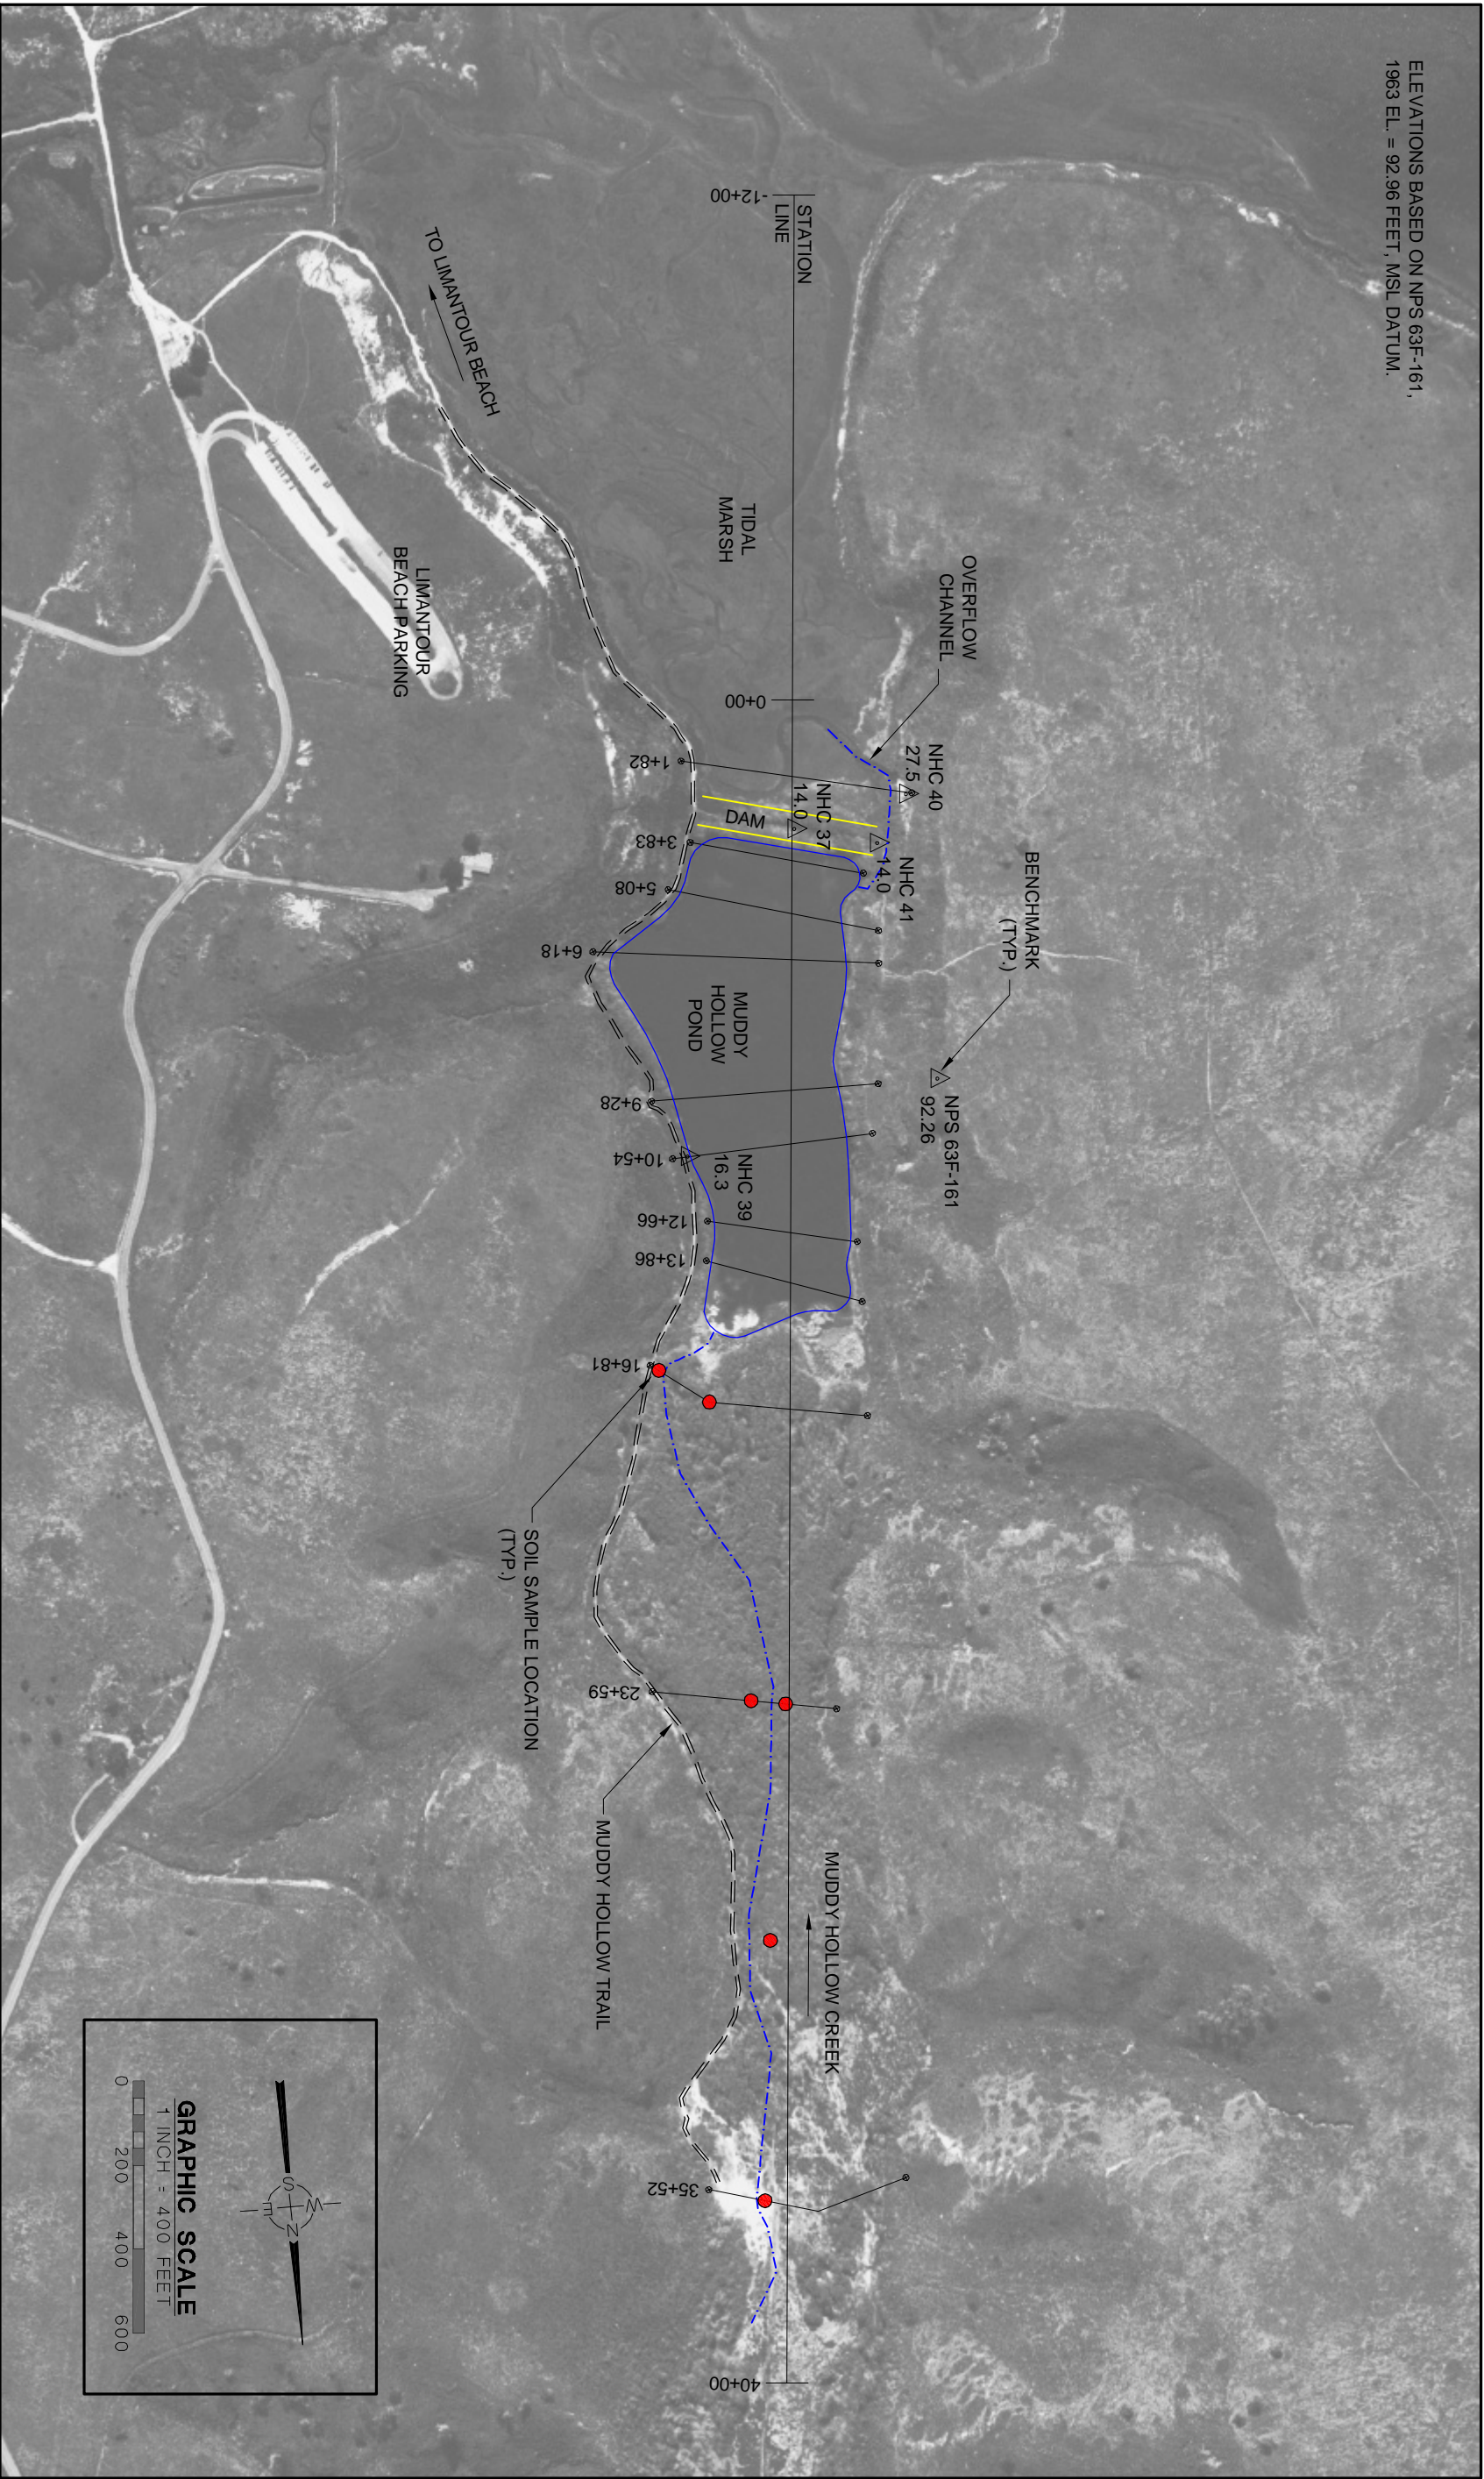
Figure 3. Muddy Hollow Creek Existing Conditions Site Plan

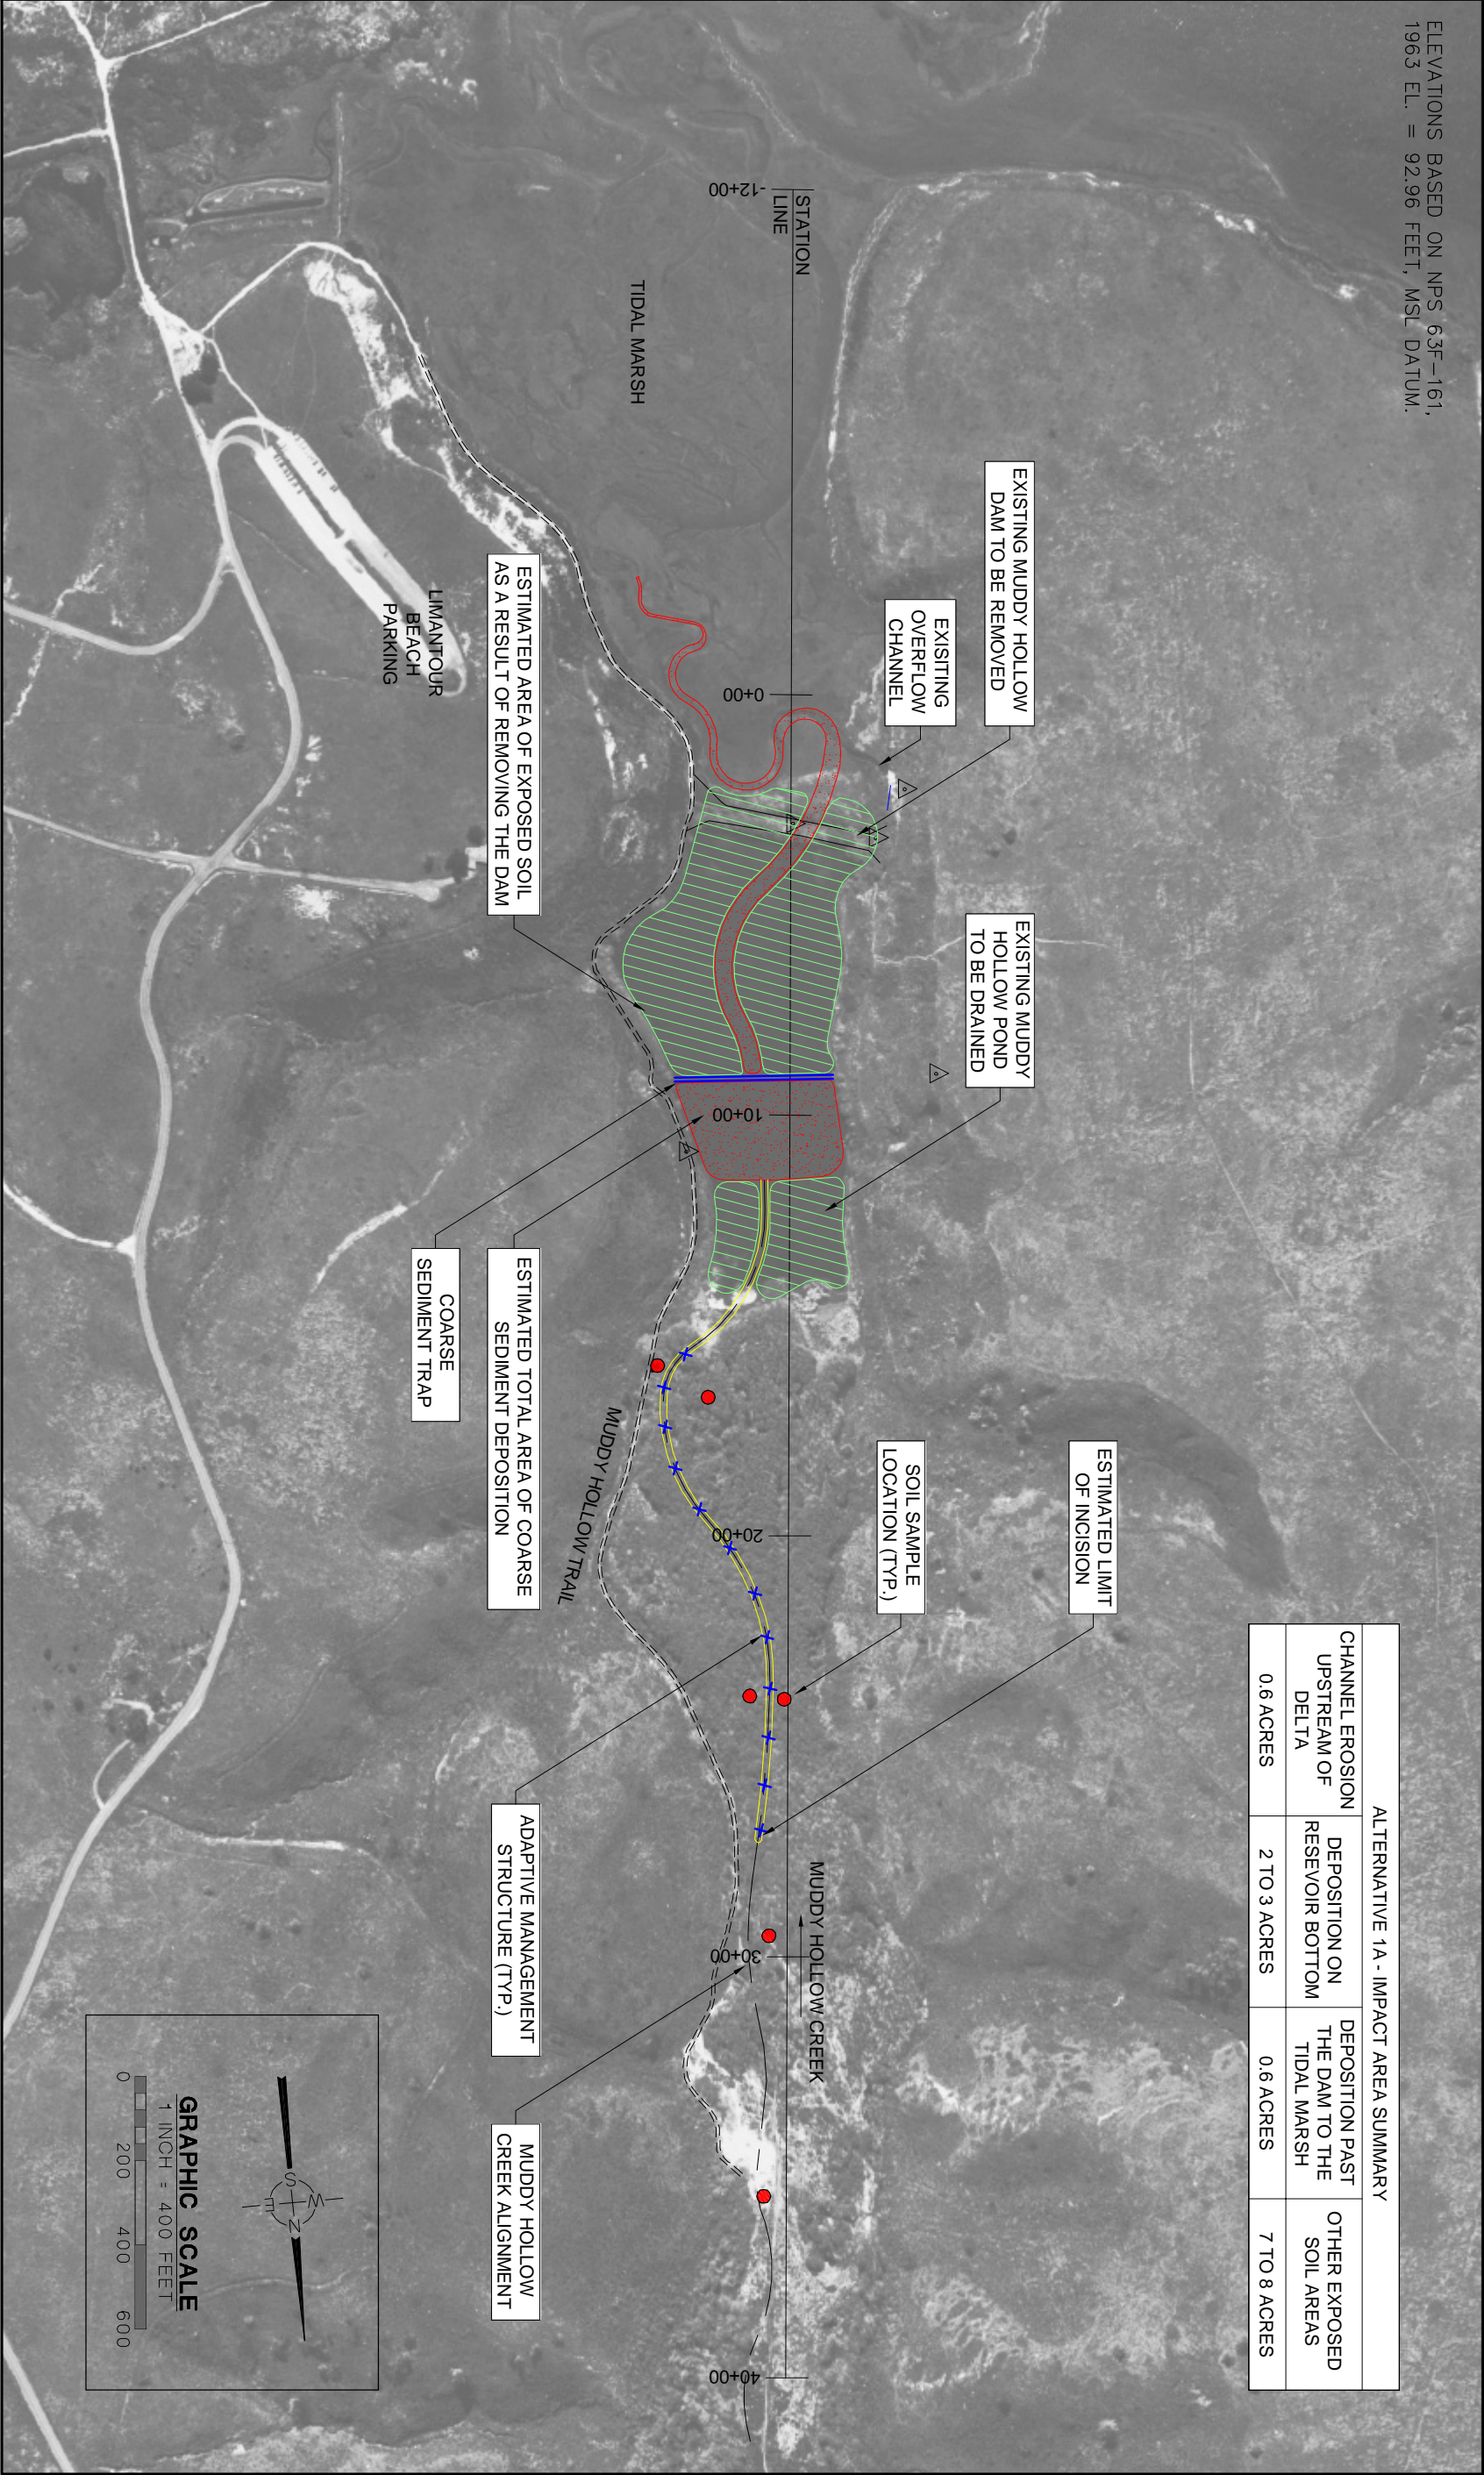
ALTERNATIVE 1A - IMPACT AREA SUMMARY			
CHANNEL EROSION UPSTREAM OF DELTA	DEPOSITION ON RESEVOIR BOTTOM	DEPOSITION PAST THE DAM TO THE TIDAL MARSH	OTHER EXPOSED SOIL AREAS
0.6 ACRES	2 TO 3 ACRES	0.6 ACRES	7 TO 8 ACRES

Figure 7. Alternative 1A: Muddy Hollow Creek Restoration Site Plan - Erosion and Deposition Areas with Adaptive Management

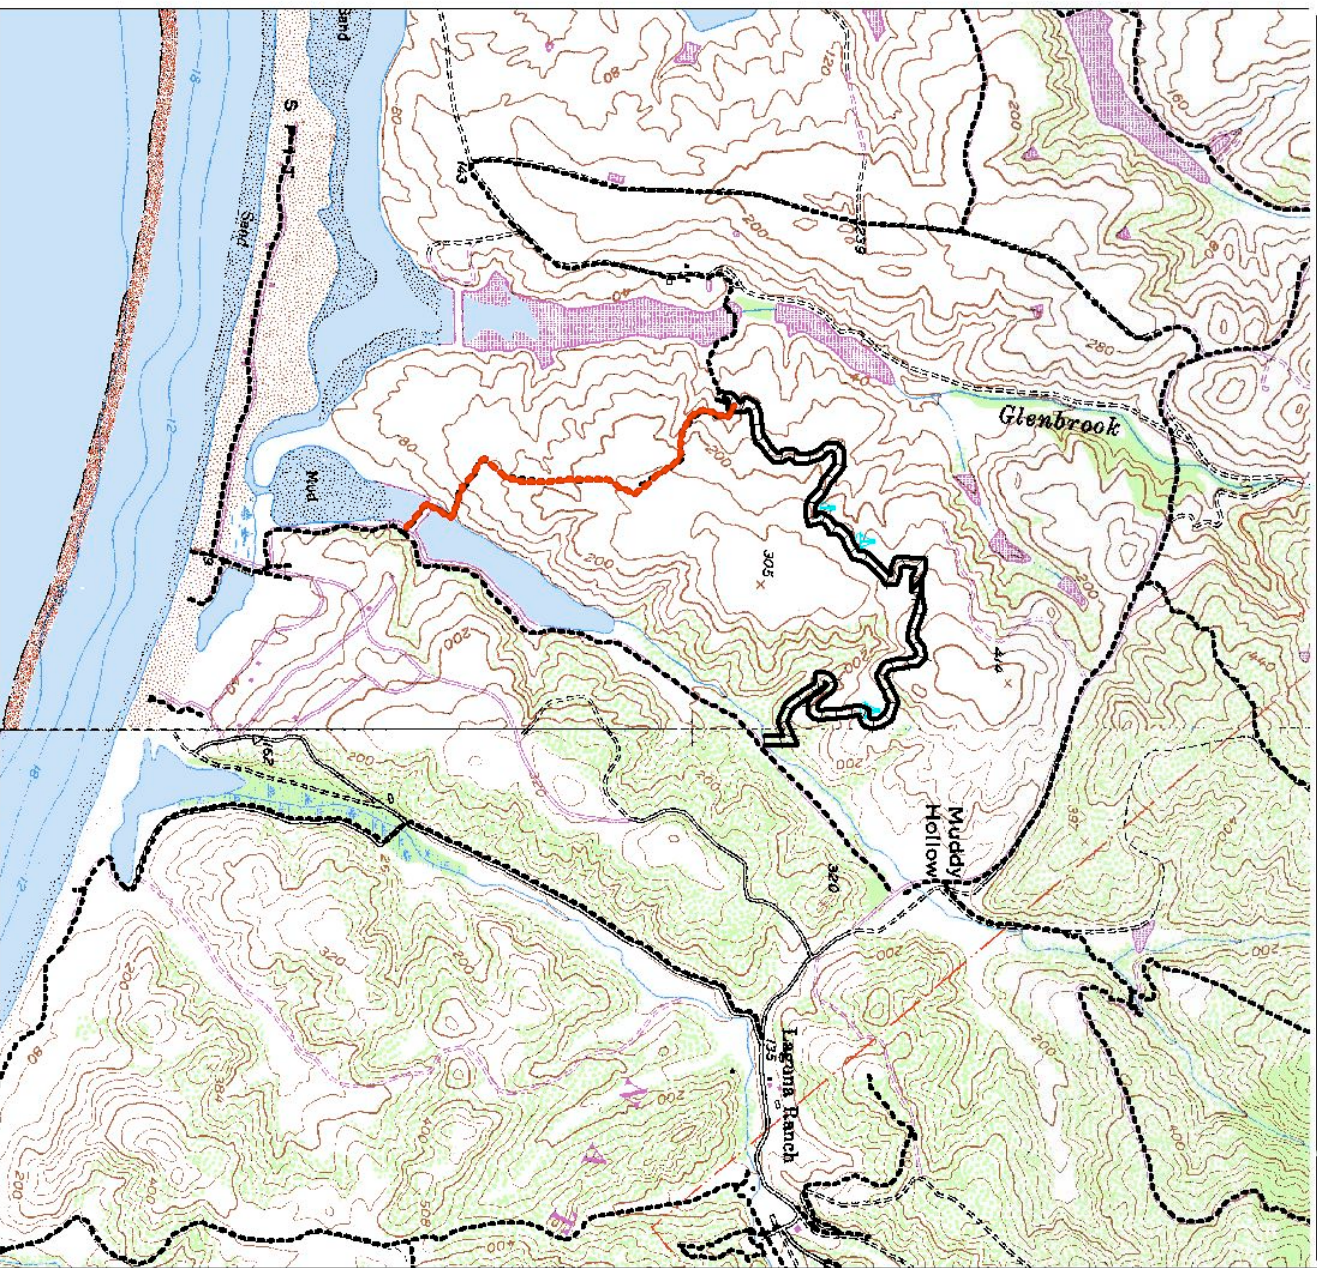
Coastal Watershed Project - Geomorphic Restoration Estero Trail Reroute Buffer

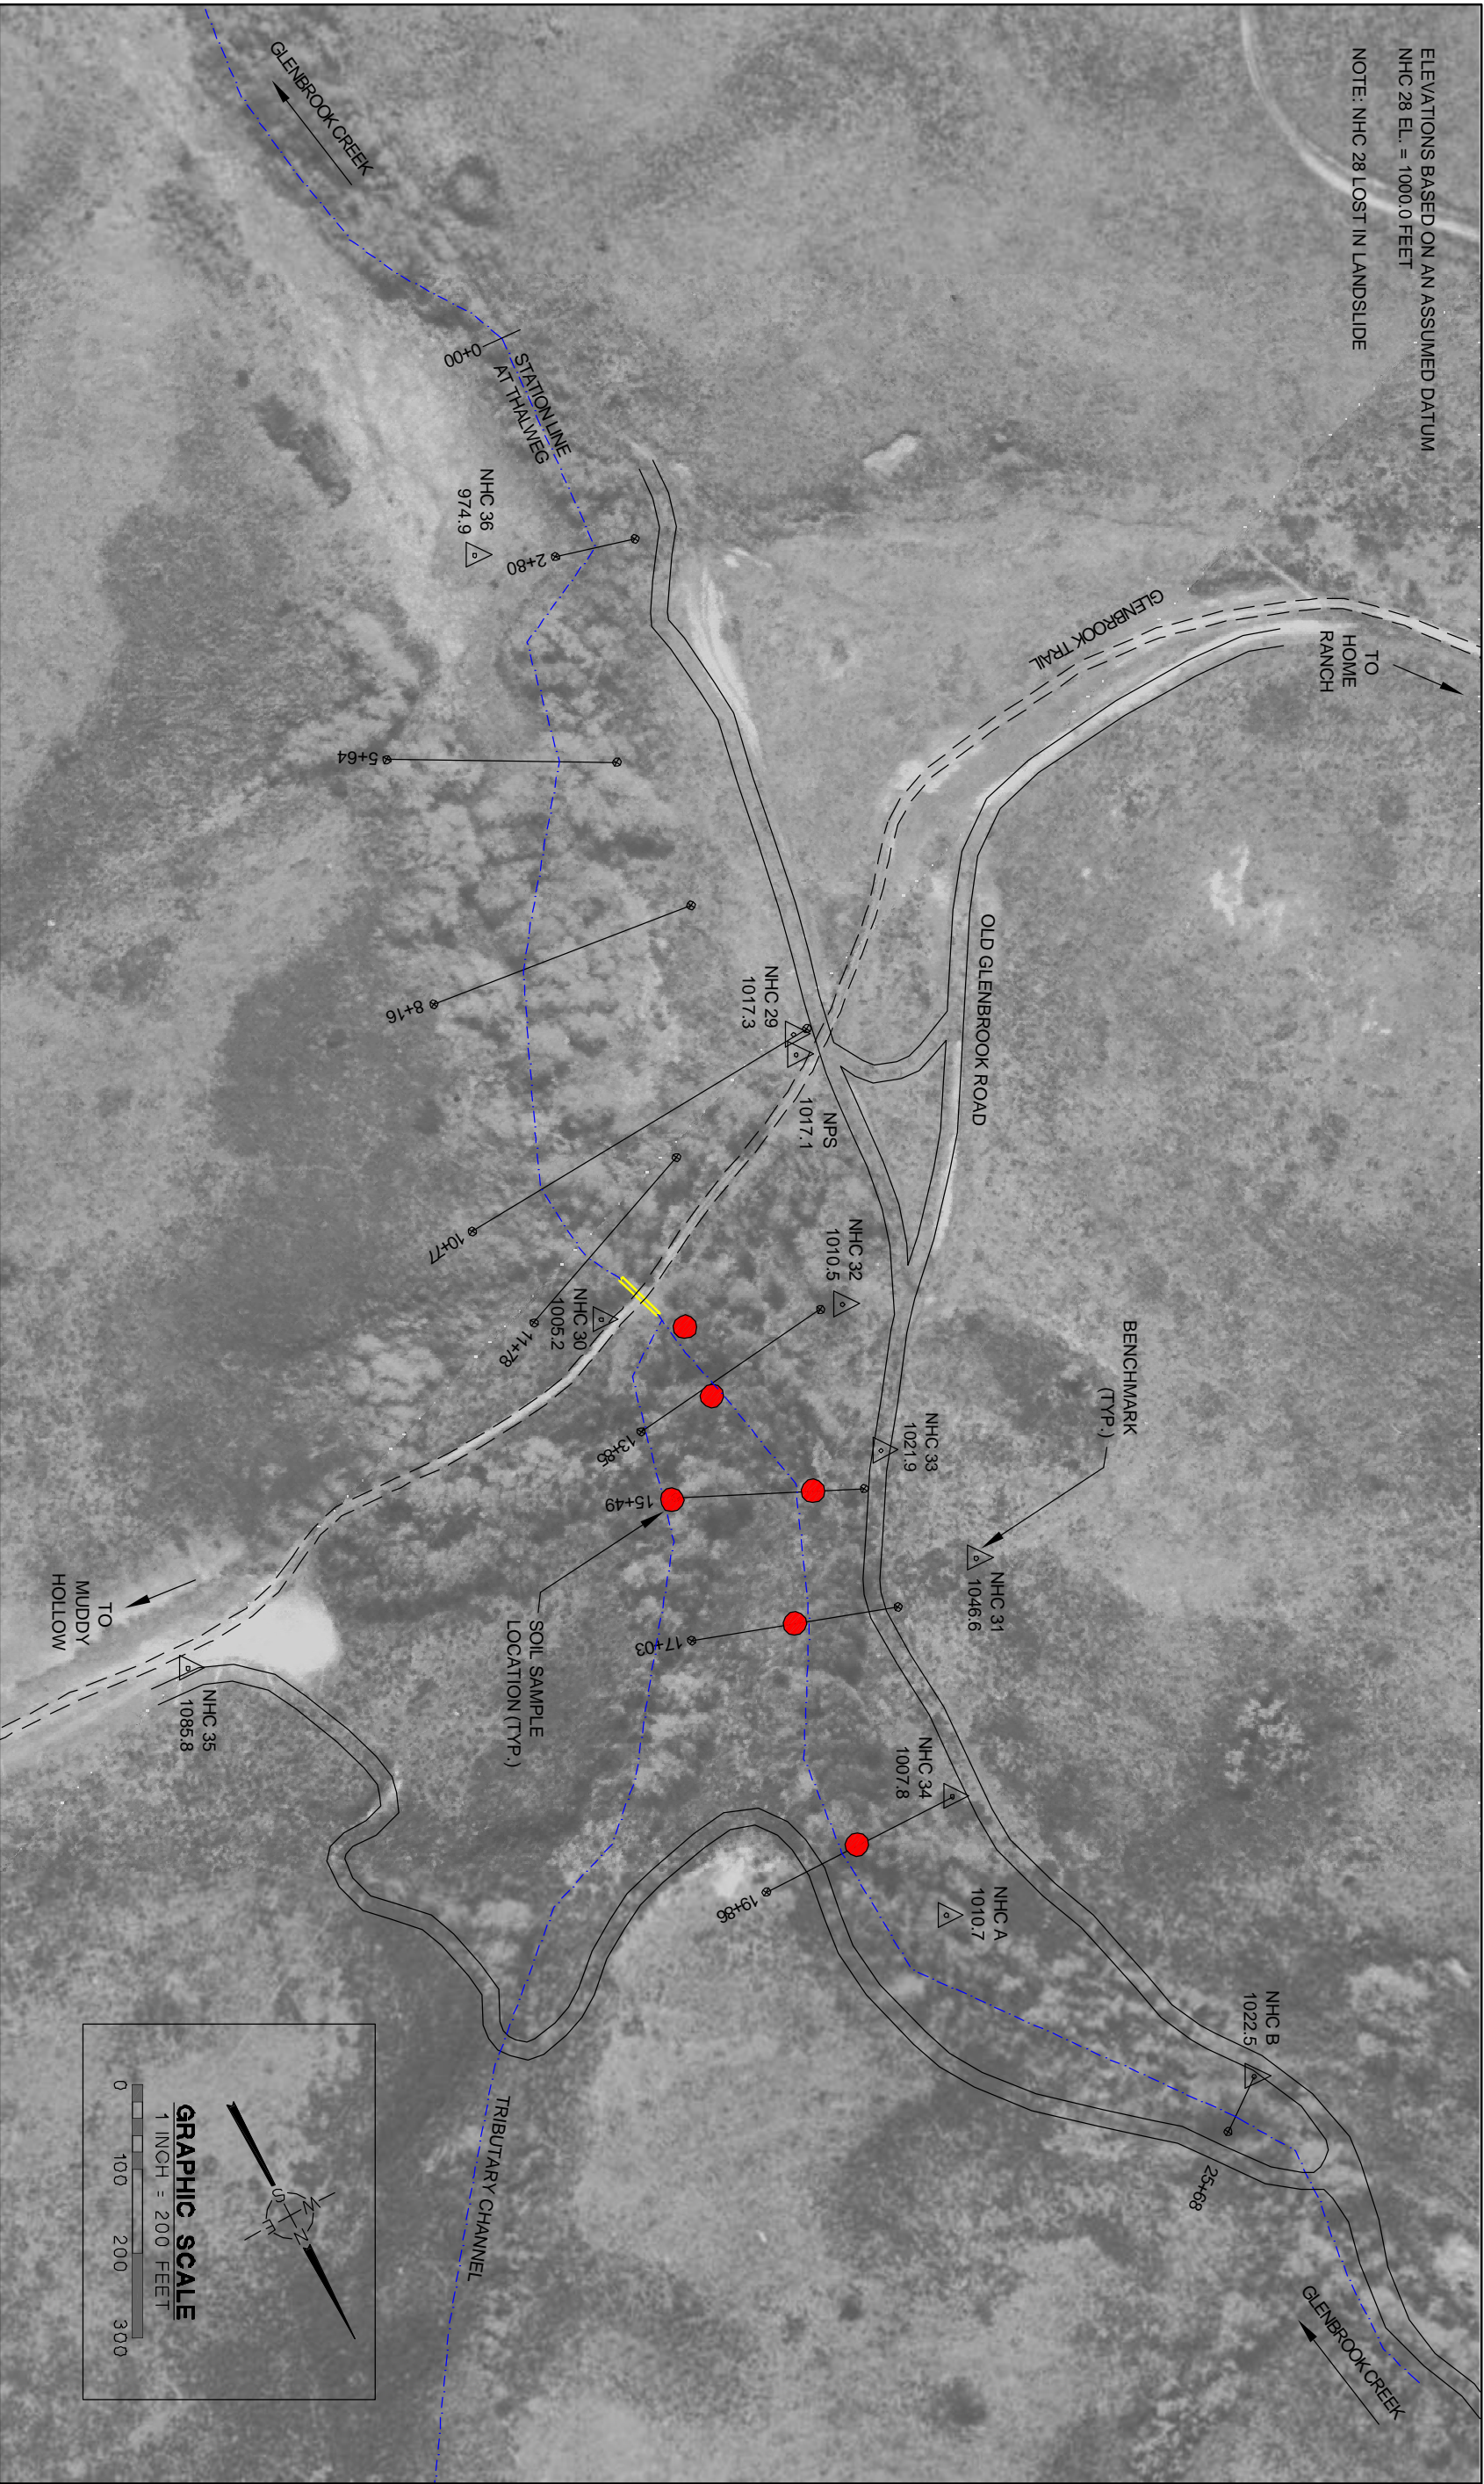
Figure 12. Glenbrook Crossing Existing Conditions Site Plan
